Elite Pipeline Services
www.elitepipeline.com

Rehabilitation of Contaminated Pipelines

Boron Recovery - 3" Relining @ 40ft

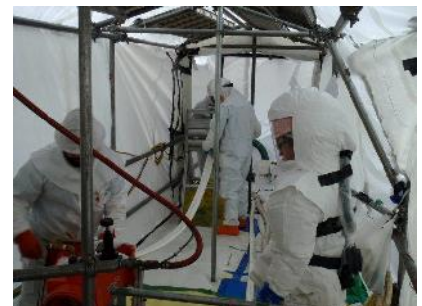
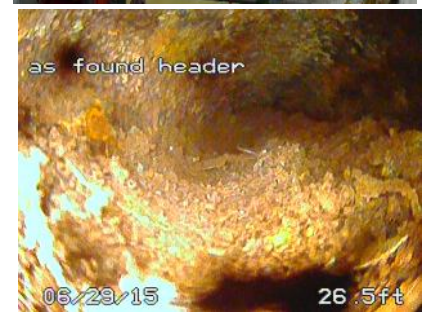
We mechanically cleaned and removed debris without using water or air, which would have generated large amounts of contaminated wet waste and possible airborne activity. Spiral brushes and a mechanical auger were used to remove the debris. We gradually removed and collected the debris into rad bags. We would place 2-3 handfuls of debris into rad bags and pass it to the Health and Physics Department (HP). HP would then frisk the debris to find levels from 0-300 millirem per hour. It took EPS six days to remove all scale from the

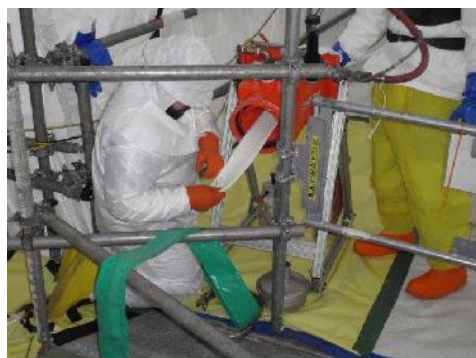
Installing the liner

After inspecting and cleaning the pipe, it was now time to install a CIPP liner. EPS technicians used a super-flex 4.5mil felt liner with a two-component resin, which consisted of a one-component hardener and a one-component silicate resin, which can withstand temperatures in excess of 325° Fahrenheit without softening. They had approximately one hour work time to mix and then invert the liner. Elite personnel had to wear double PCs and hoods outside the containment tent while mixing the resins and wetting out the felt liner. A resin slug was then poured into the felt liner, with a vacuum pump installed on the opposite side. The mixture ran through a series of rollers and impregnated the felt liner with the resin.

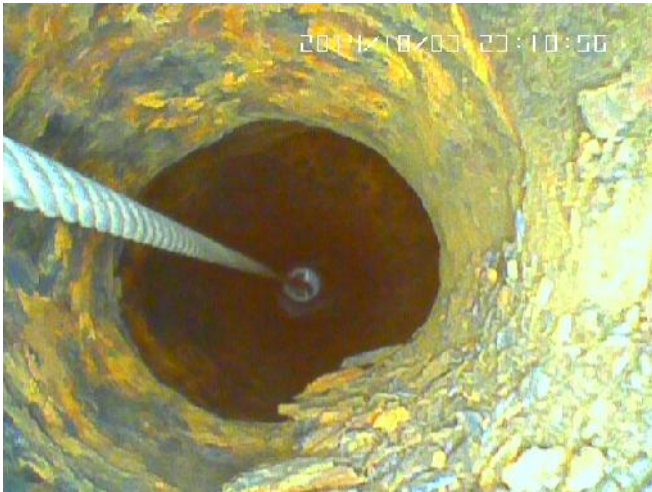
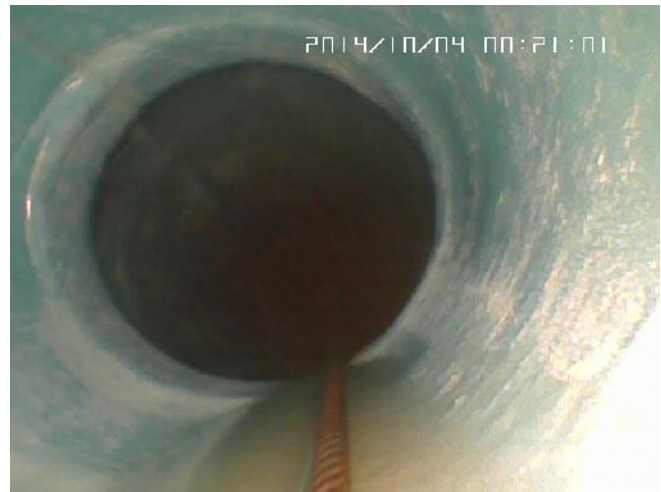
Pulling in a 6" to 4" Transitional Liner, Through a 2" Access Point.

A nuclear facility required that their buried Max Recycle radioactive Equipment and Floor drain pipe be relined, totaling 206 ft. The main trunk line of these pipes is 6 inch in diameter. There were two separate lines, with 19 reinstatements in total. A Hydrolasing unit was required for cleaning with a capped pressure of 1800 psi. The waste water and sludge was directed to a catchment/rad waste barrel configuration hold and separate wet waste and contaminants liquid waste was pumped into the existing rad waste floor drain system. Both lines had elevations throughout the piping system. Access to the buried pipe was possible by a newly installed concrete vault and through a cordoned off room in the Max recycle building. Access point's within the Max Recycle building was 2" and 4" in diameter, which allowed the access needed for technical installation of the 6" liners. Liners had to be pulled, winched, and set into place prior to installation utilizing the access points. The liner design was a slow cure, with 100% coverage, and was required to withstand 180 degrees during operation. With limited access points to reinstate the lateral drain lines, with sizes ranging from 2" – 4", a robotic air driven cutter had to maneuver up elevations, and reinstate these lateral drains from more than 100ft from access. During this entire evolution HP/RP support, Task managers, security and project management was required to oversee and maintain a safe working area for Elite to work in, which made for a successful project.
