4" Fuel Building Basement Relining

Introduction to Project

In February of 2014, Elite Pipeline Services completed a 4" Fuel Building Drain [Specialty Relining Project](#). The purpose of the project was to lower tritium levels surrounding the Nuclear Facility within its buried piping system.

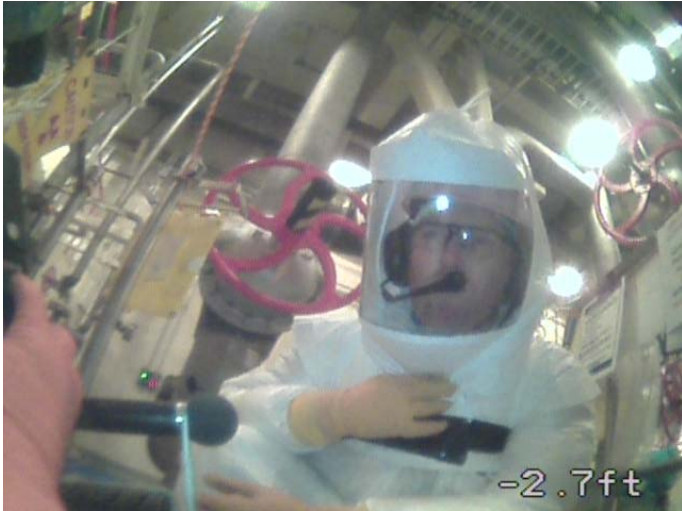
4mm lined elbow

The purpose of this relining project was to successfully clean and install new 4mm liners in each lateral covering 100% of the pipe configuration, including lateral connections and elbows. The resins were a two-part mixture with short curing time.

In previous small diameter projects, we have completed them by using an inversion process, which is just for straight sections of pipe. We had to opt for a pull and drag lining method for this project in order to ensure 100% coverage on elbows, branch lines, and connections. This method requires three access points to pull into place. EPS required a technician on the branch line, one on the downstream, and one on the upstream. The technicians were effectively installing a T- Section midway, which requires tension on all ends before inflating. Getting this wrong can lead to failure. During cleaning and installation of the liners, EPS technicians had multiple bore scope cameras to assist on precision cleaning and accurate installs of liners.

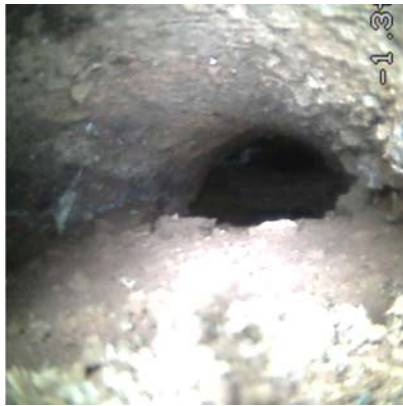
Pre-Cleaning

The first step of this project was to clean all of the pipe headers and branch lines. The cleaning began by using a vacuum method, but various other methods were later implemented when vacuuming was not completely successful in bringing the pipe wall to a state where it was ready to re-line. A Radiological shield box was also installed by Engineering services in the sump (lower dose rates in this area), which allowed the EPS team to easily gain access and remove debris while lowering overall dose. The sump box was a successful step for the technicians, as it separated them from the contaminated water and debris. The vacuumed debris was contained into Rad Waste Drums. **(Removing and containing debris of up to 300mr during the cleaning stage)**

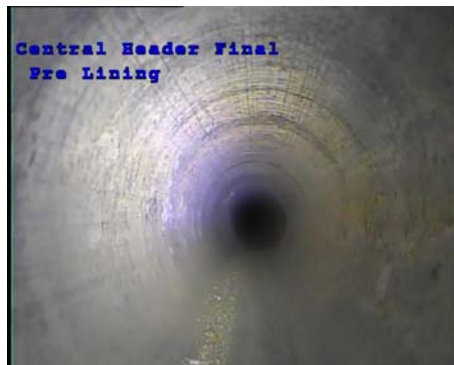
After Cleaning

Once vacuuming was complete, it was time to run carbide fingers in a clock wise rotation by electric cabling, followed by the vacuum to minimize airborne activity. All drain outlets were sealed during this process. This method provided us with a clean pipe wall for our resins and liners to adhere to.

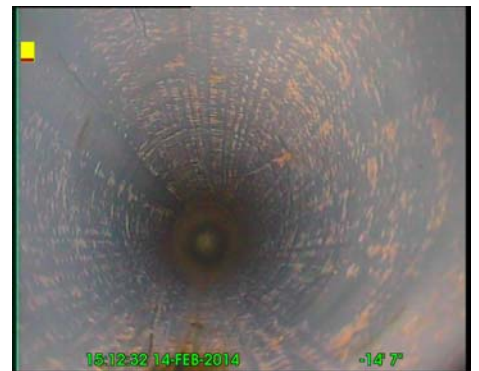
Post-Lining

The first part of the relining stage was to reline the main headers, which was approximately 65ft of the total 100ft pipe system. The reline process was a pull-in system. This stage of the project was the utmost of importance to manage curing times and dose rates. EPS technicians would have to dress up in full PC's and Hoods outside the designated working area. They would then prepare the liners, wet them out, carry them down a stairwell, and then into the work zone. Once in the work zone, the liner was installed by pull and drag. It was then inflated in a psi range of 12-15kpa. Due to the heat in the basement and outside temperatures, these main headers were installed within 1hr of mixing the resins. Wearing Hoods and Respirators also affects movement and efficiency. There were no issues during these installs.
